WALDEN GENERAL STORE

Walden, Vermont

PHASE I ENVIRONMENTAL SITE ASSESSMENT

February 3, 1998

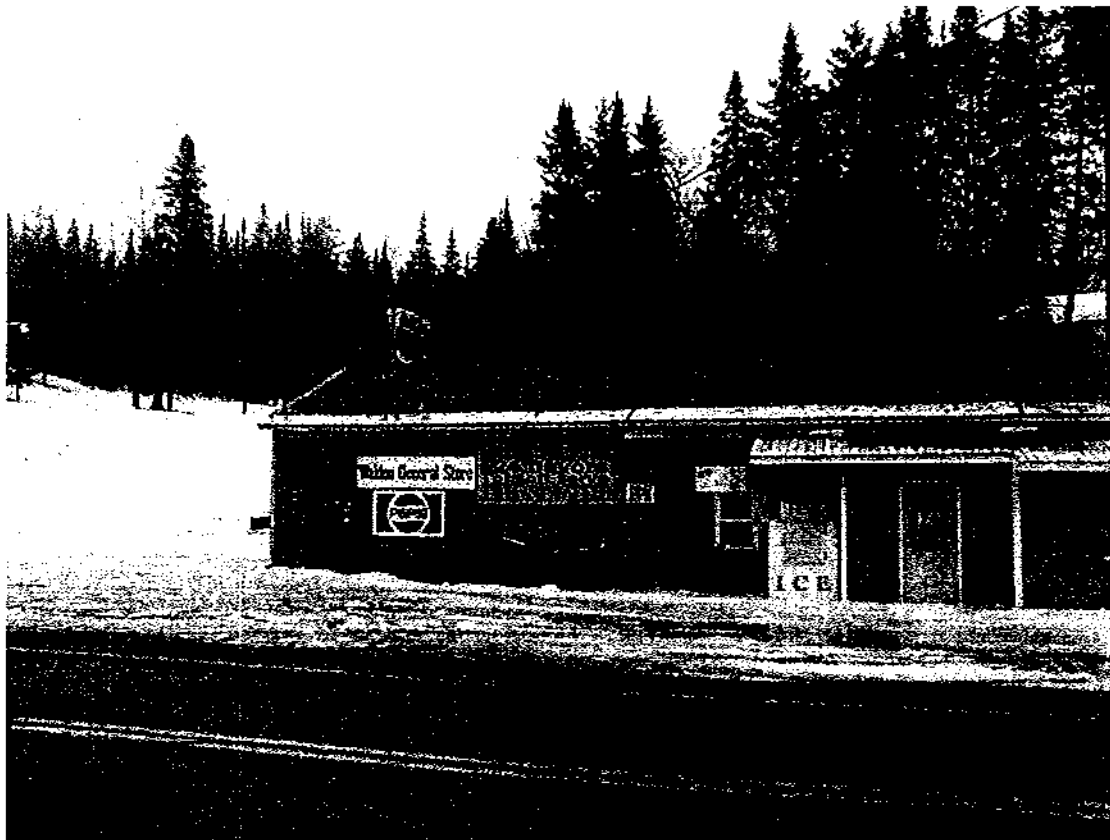
North side of the Walden General Store. Gasoline pumps were located in the front of the store.

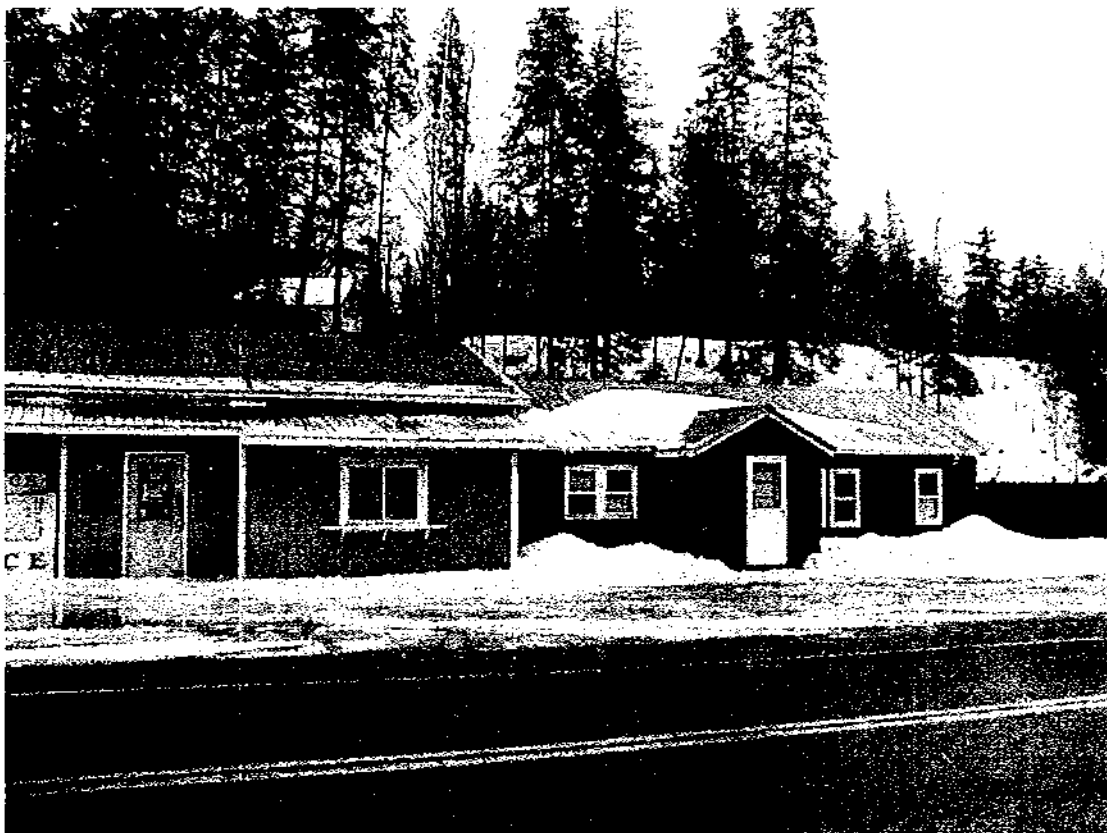
South end of the General Store with the apartment connected. Notice the steep slope east of the property.

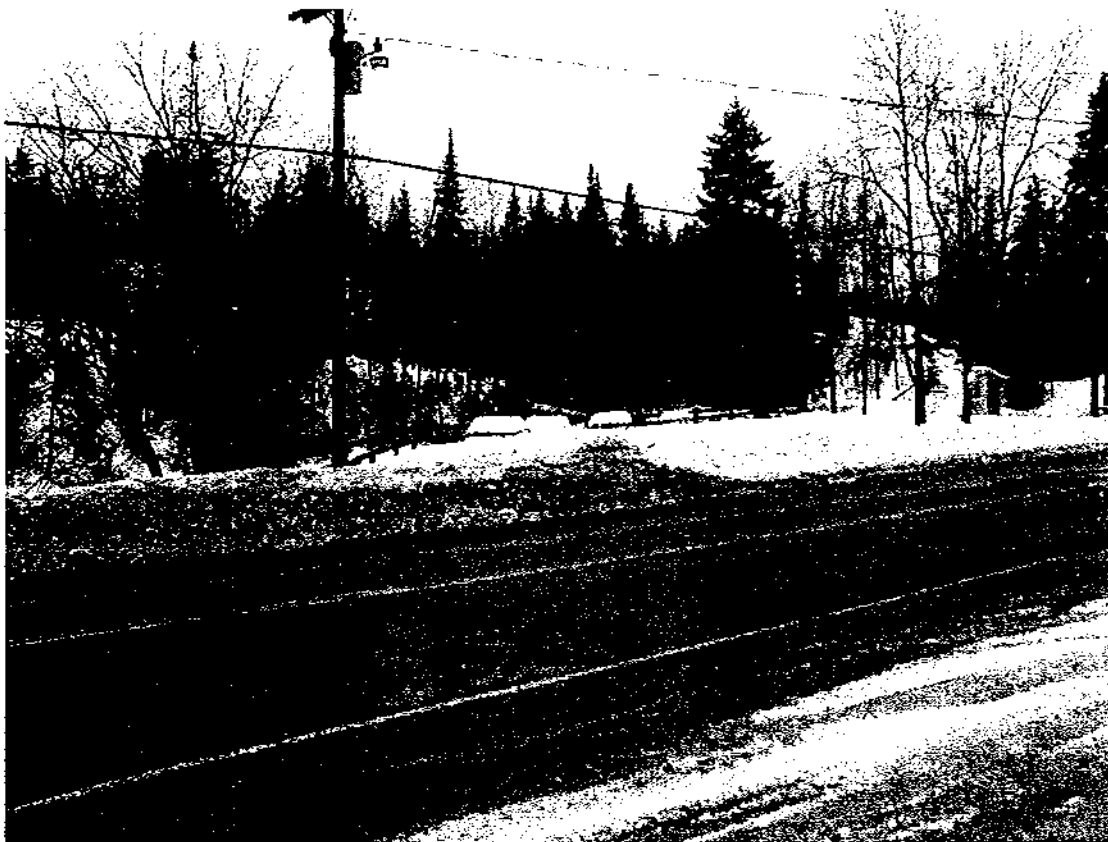
The subject property is located on Route 15 in Walden, Vermont. There is one pole-mounted transformer on Route 15 across from the general store. According to Mr. Steve Anderson of the Washington Electric Co-op, the transformer has not been tested for PCBs.* The transformer appeared to be in good condition and rust-free. There were no signs of spills or leakage on the ground below the transformer.

Route 15 and Joes Brook located west of the Walden General Store. Notice the pole mounted transformer.

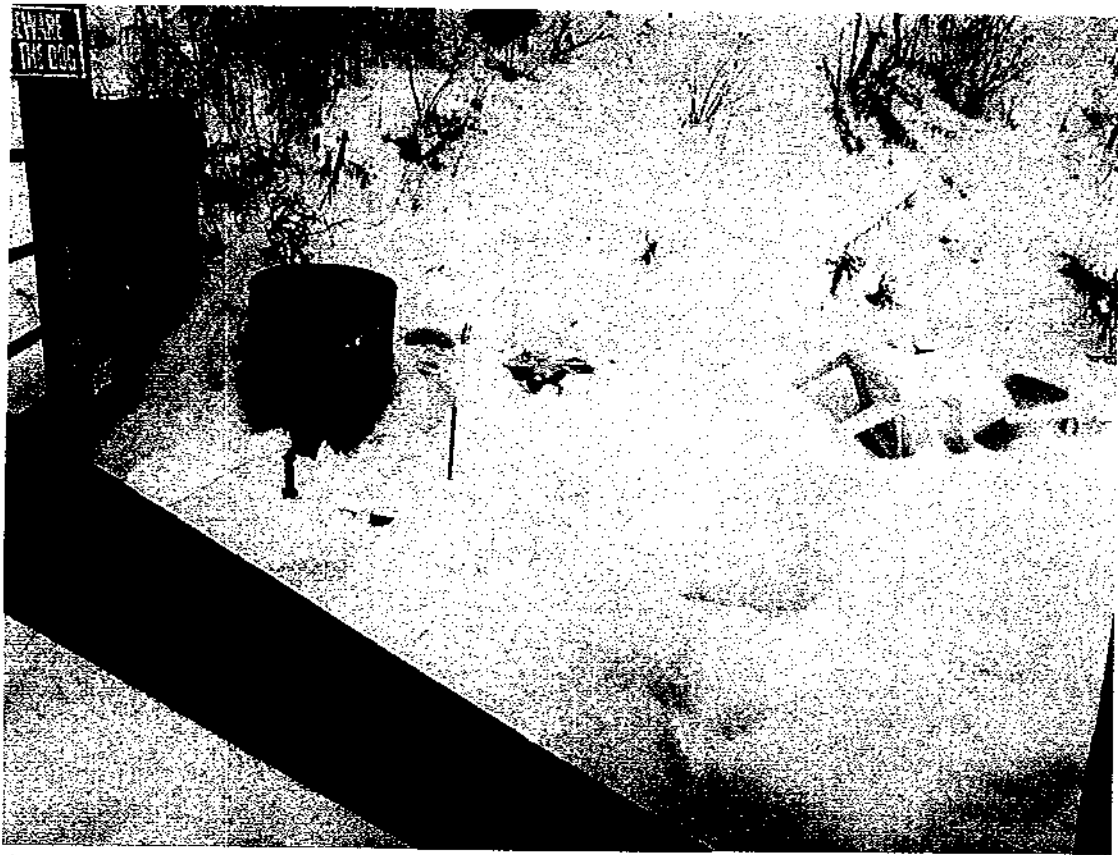
The ground was covered with 2-3 feet of snow, so the ground surface was not easily observed. There were some rusty barrels and debris buried in the snow to the northeast corner of the store. One of the barrels had a gasoline odor. Ms. Beaupre was uncertain of the contents of the barrel. No other evidence of disturbed soils or chemical spills, and no unusual odors were observed at the site.

Junk and rusty barrels buried in the snow east of the store.

8. Rusty barrels and debris were located to the northeast of the store. One of the barrels evidenced a strong gasoline type odor. Heindel and Noyes recommends properly disposing of the 55-gallon barrels and inspecting the areas for evidence of surface releases.
